Upper Mokau/Mangapehi & Upper Mangaokewa
Freshwater Monitoring Results
Merrin Whatley (PhD) – 25 July 2022

Overview

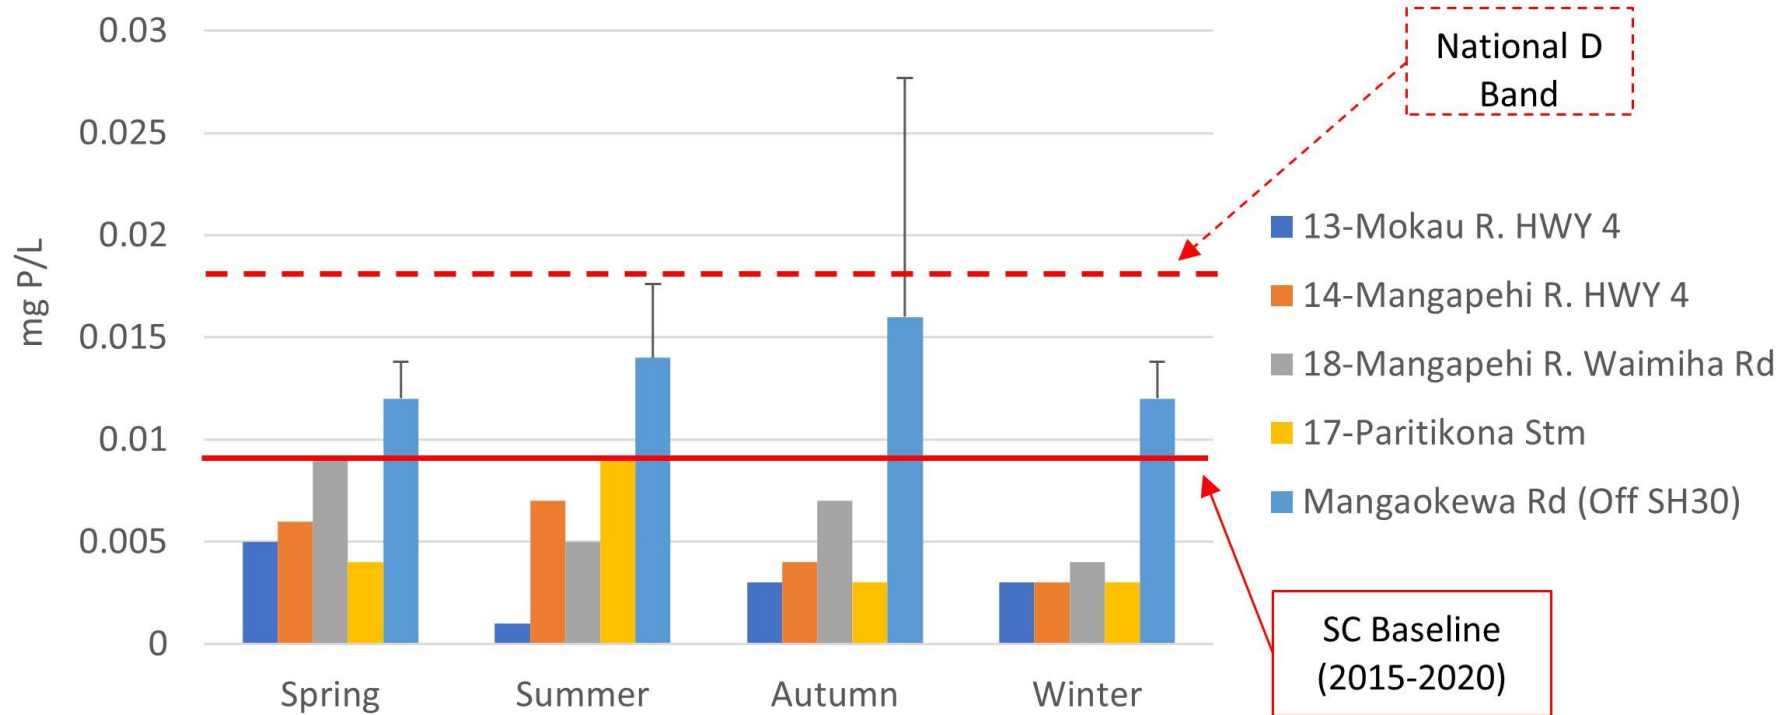
DRP – Seasonal Results

Upper Mokau-Mangapehi Dissolved Reactive Phosphorus - Median

- E. coli and water clarity are the attributes to watch
- DRP is elevated at Mangaokewa Rd
- Water clarity is lowest at 14-Mangapehi R.
- Highest WQ at 13-Mokau R. & 17-Paritikona stm.
- Lowest WQ at Mangaokewa Rd

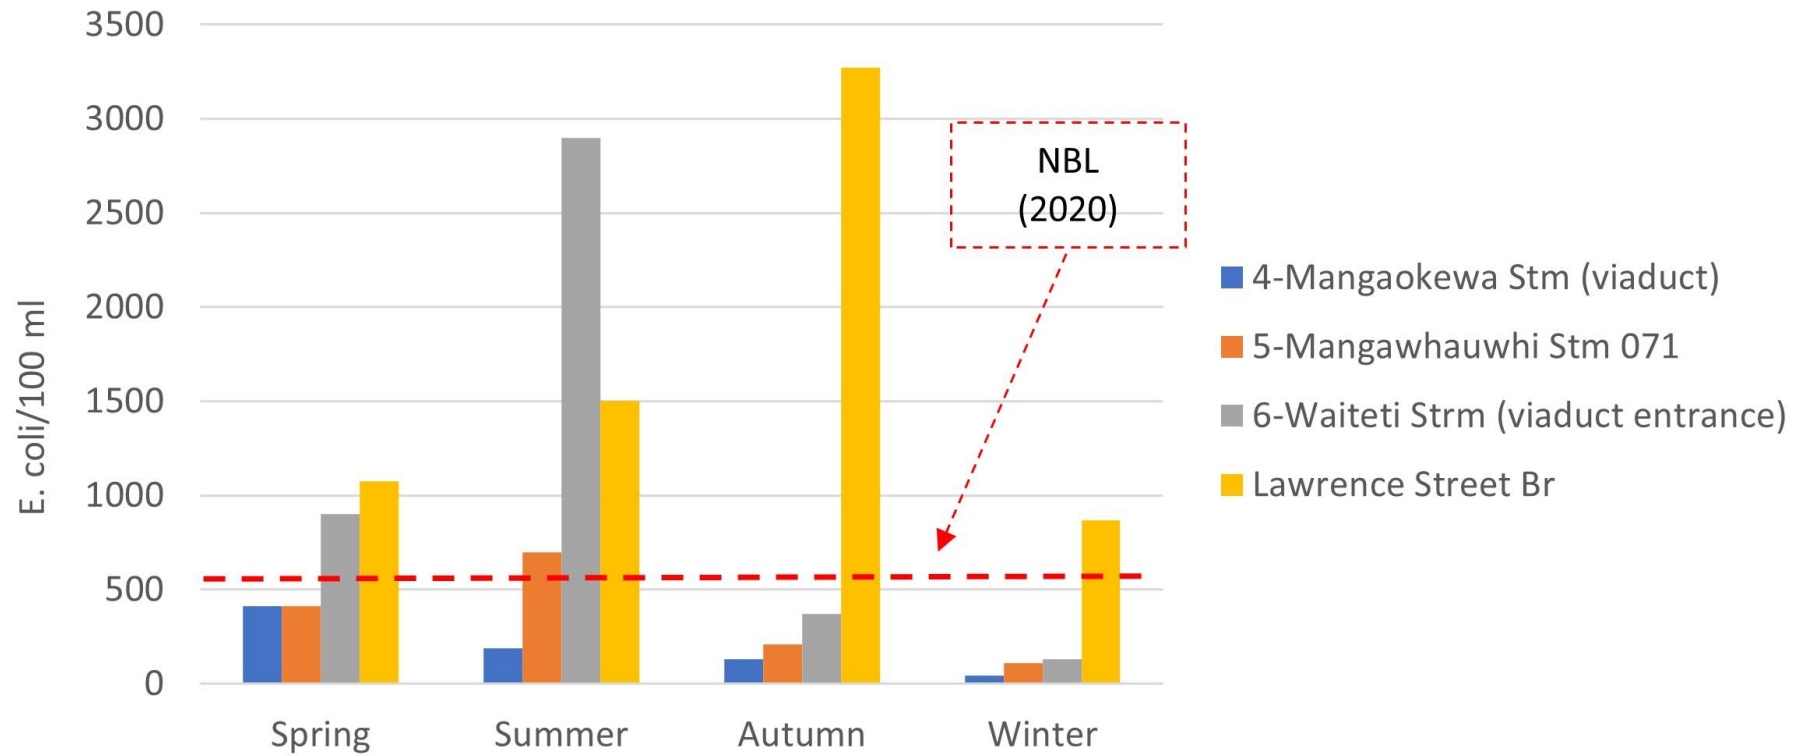
E. Coli – Seasonal Results

Upper Mangaokewa E. coli - 95th Percentile

- E. coli, nitrate and ammonia are the attributes to address
- DRP is elevated at Lawrence st bridge
- Water clarity is lowest at 6.Waiteti stm
- Highest general WQ at 4.Mangaokewa
- Lowest general WQ at 6.Waiteti

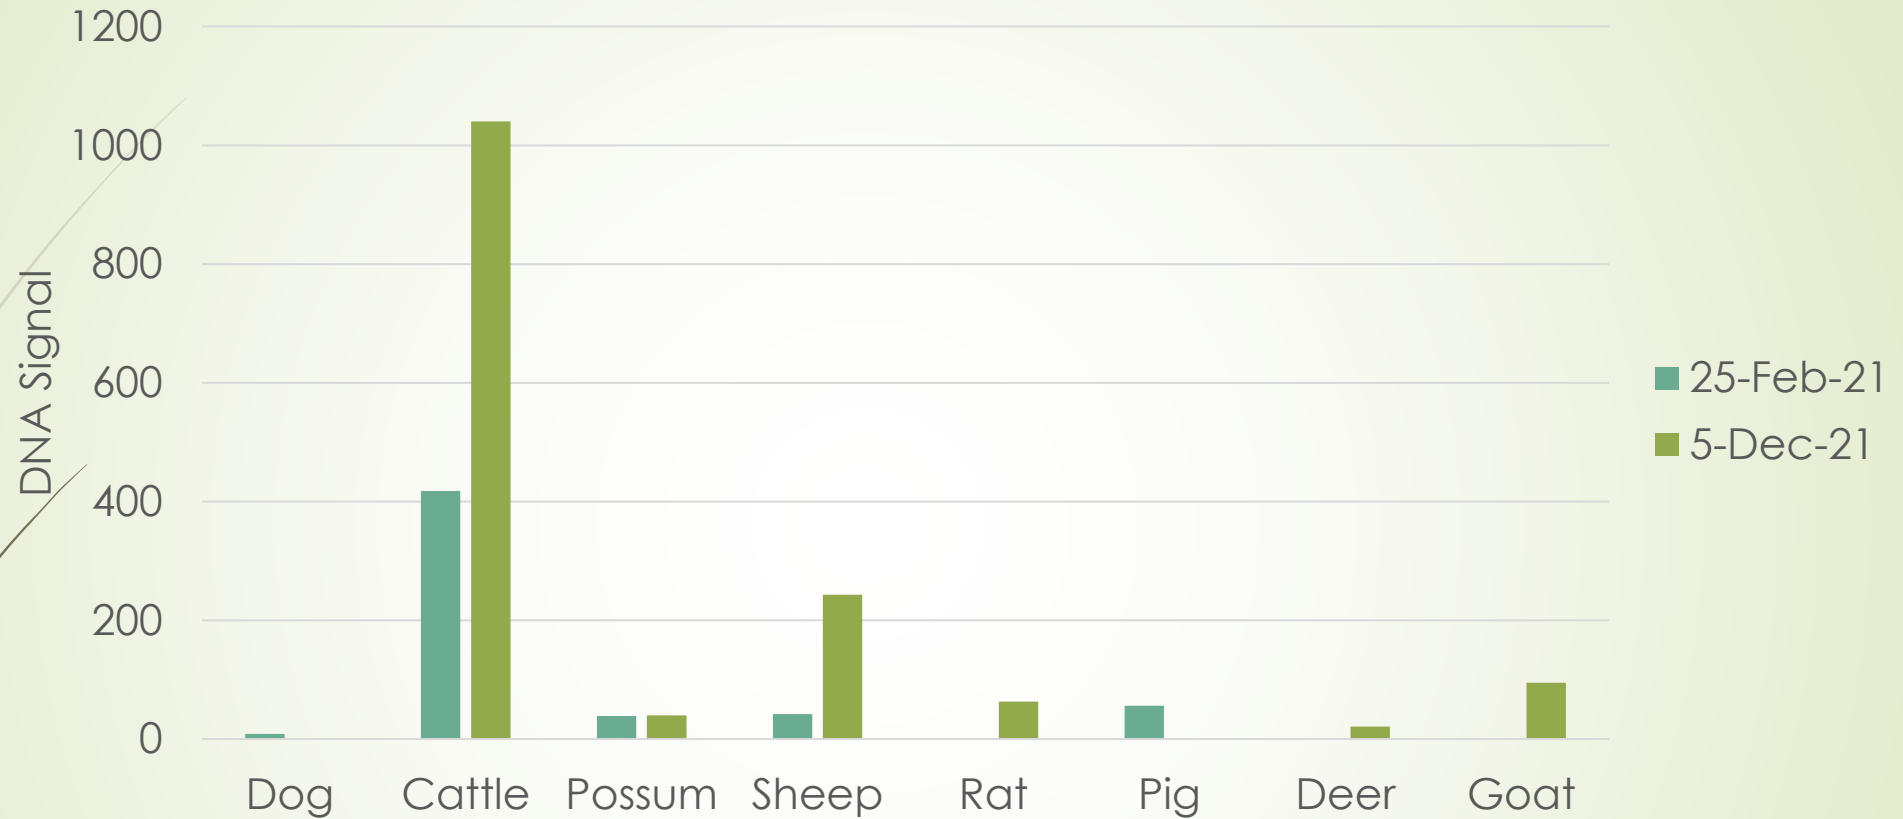
Mammalian eDNA Signal Strength

Mammals - 14. Mangapehi Stream

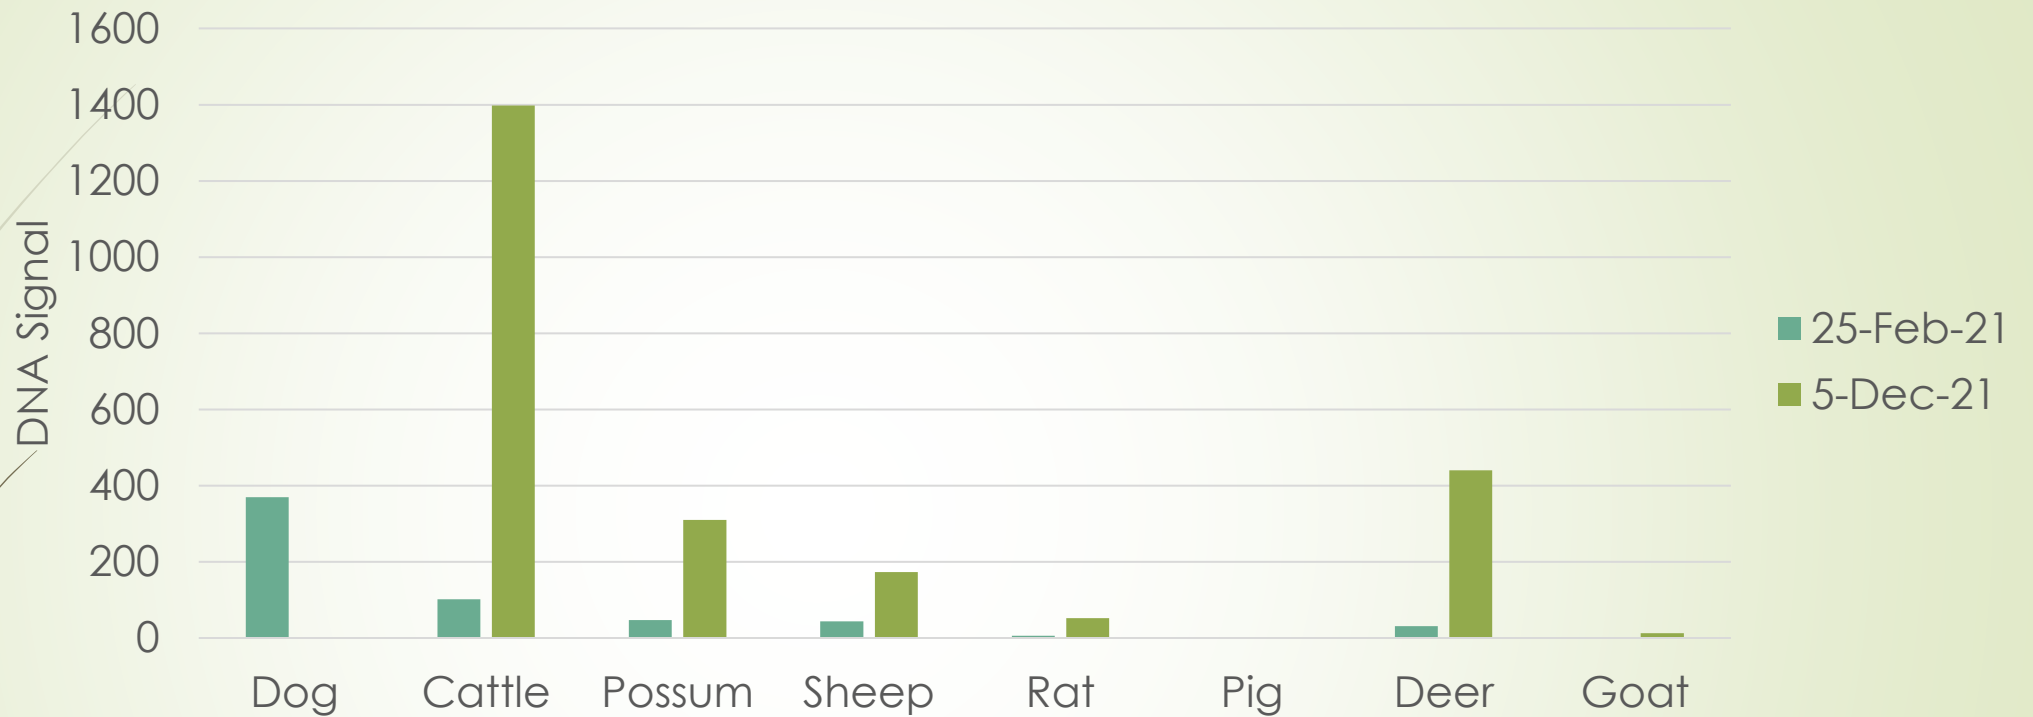
Mammalian eDNA Signal Strength

Mammals - 4. Mangaokewa Stream

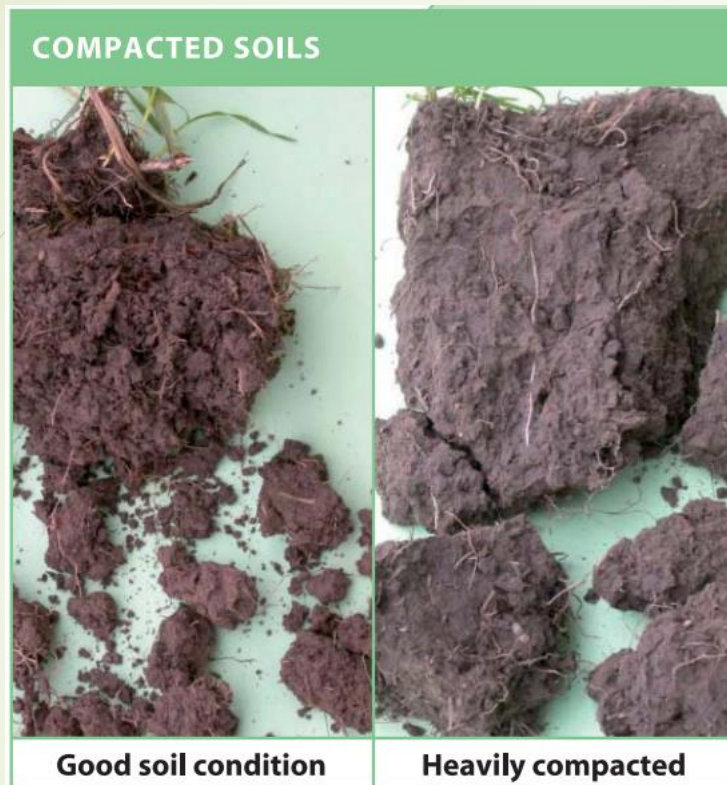
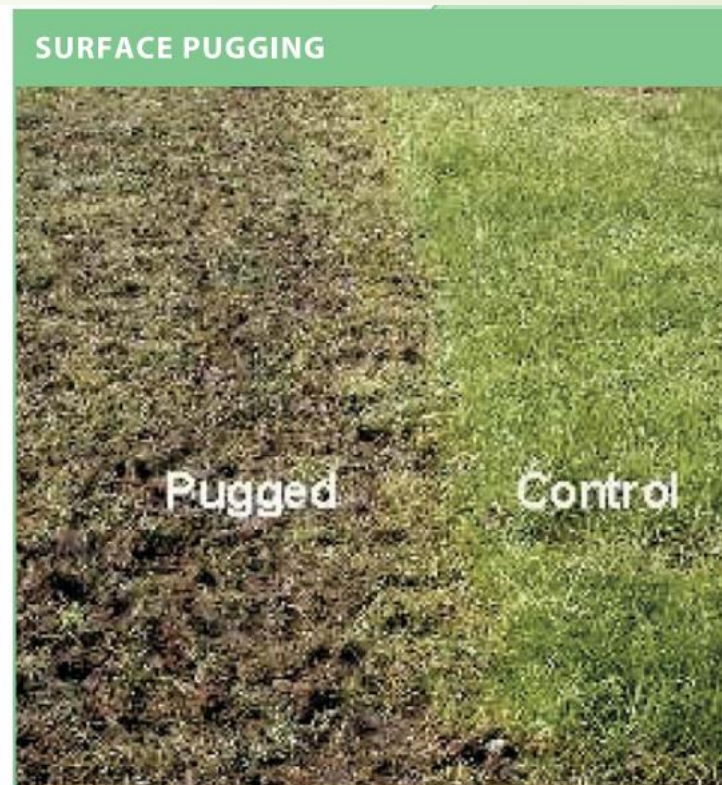
Soil Damage - Pugging

Overgrazing & soil damage

- Reduces spring pasture production by up to 80%
- Can take 3 or more years to recover.

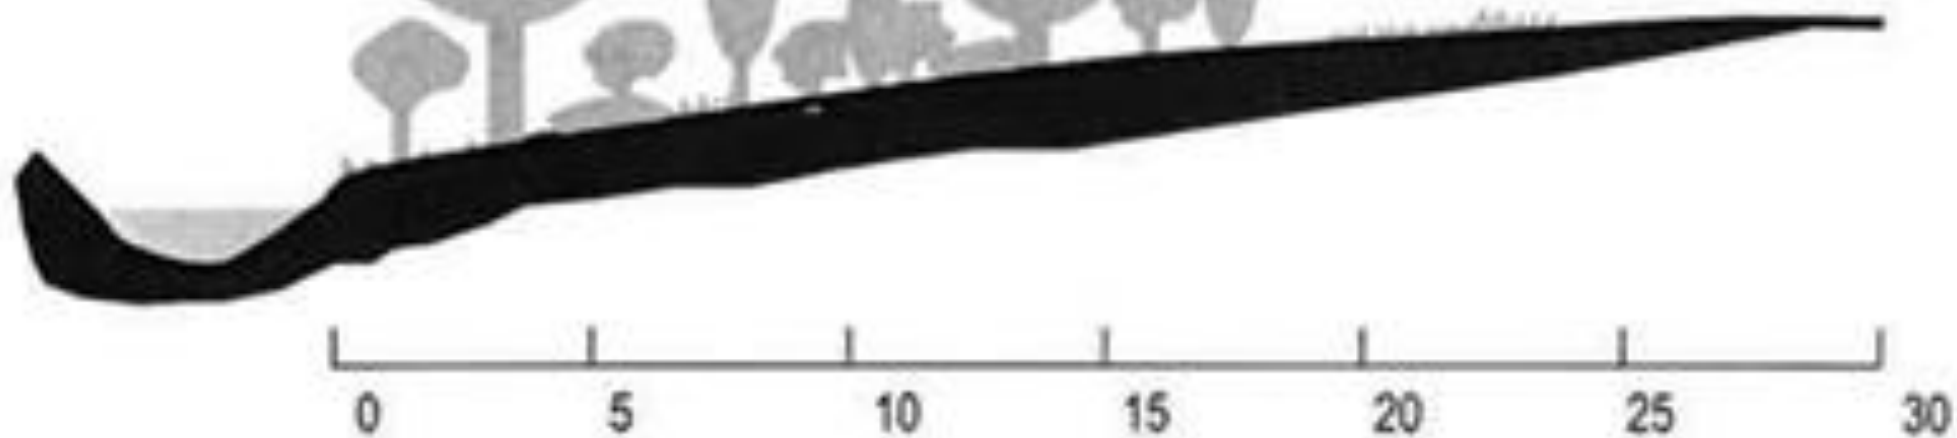
Functions of riparian buffers

Livestock damage

Fish habitat

Bank stability

Flood control

Shade

Leaf input

Filtration

Wood input

Nutrient uptake

Wildlife habitat

Diagram from conference paper by J Quinn (2012)
