Mapiu – Mapara Freshwater Monitoring Results Merrin Whatley (PhD) – 27 July 2022

Indicators of freshwater health

- Monitoring results
- On farm actions

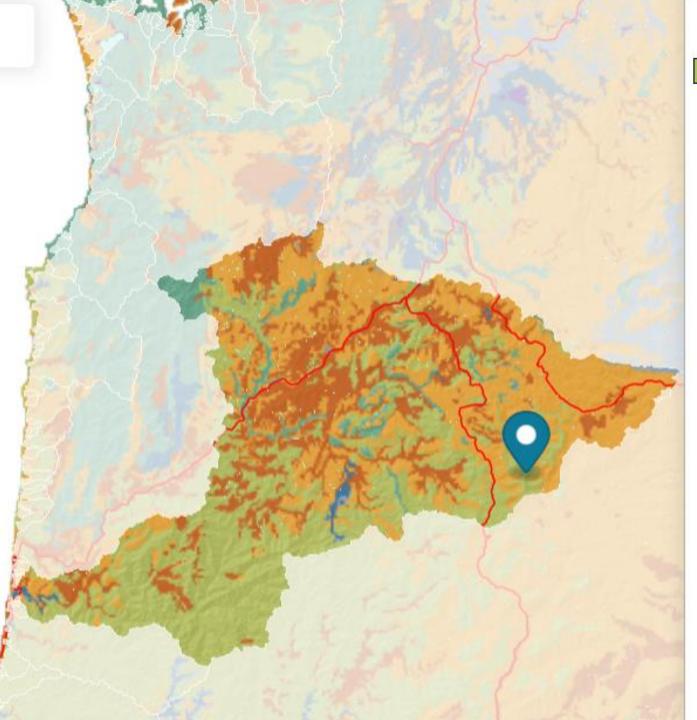
Weak Bedrock

Hydrological Pathway Lateral drainage Contaminant Risk Sediment, Particulate phosphorus

Typically occurs across rolling to steep topography where shallow soil overlies weak bedrock (also exists across plateaus where shallow soils overlie bedrock without

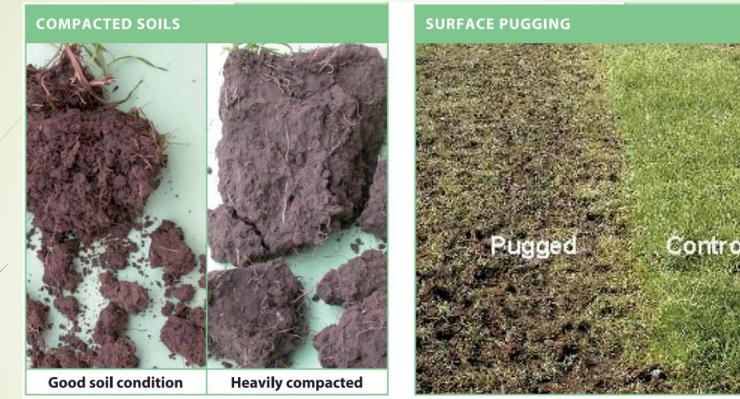
Soil Damage - Pugging

Overgrazing & soil damage

- Reduces spring pasture production by up to 80%
- Can take 3 or more years to recover.
