Mid Mokau Piopio & Mangaotaki-Mairoa
2021 Freshwater Monitoring Results
Merrin Whatley (PhD) – 26 July 2022

Overview

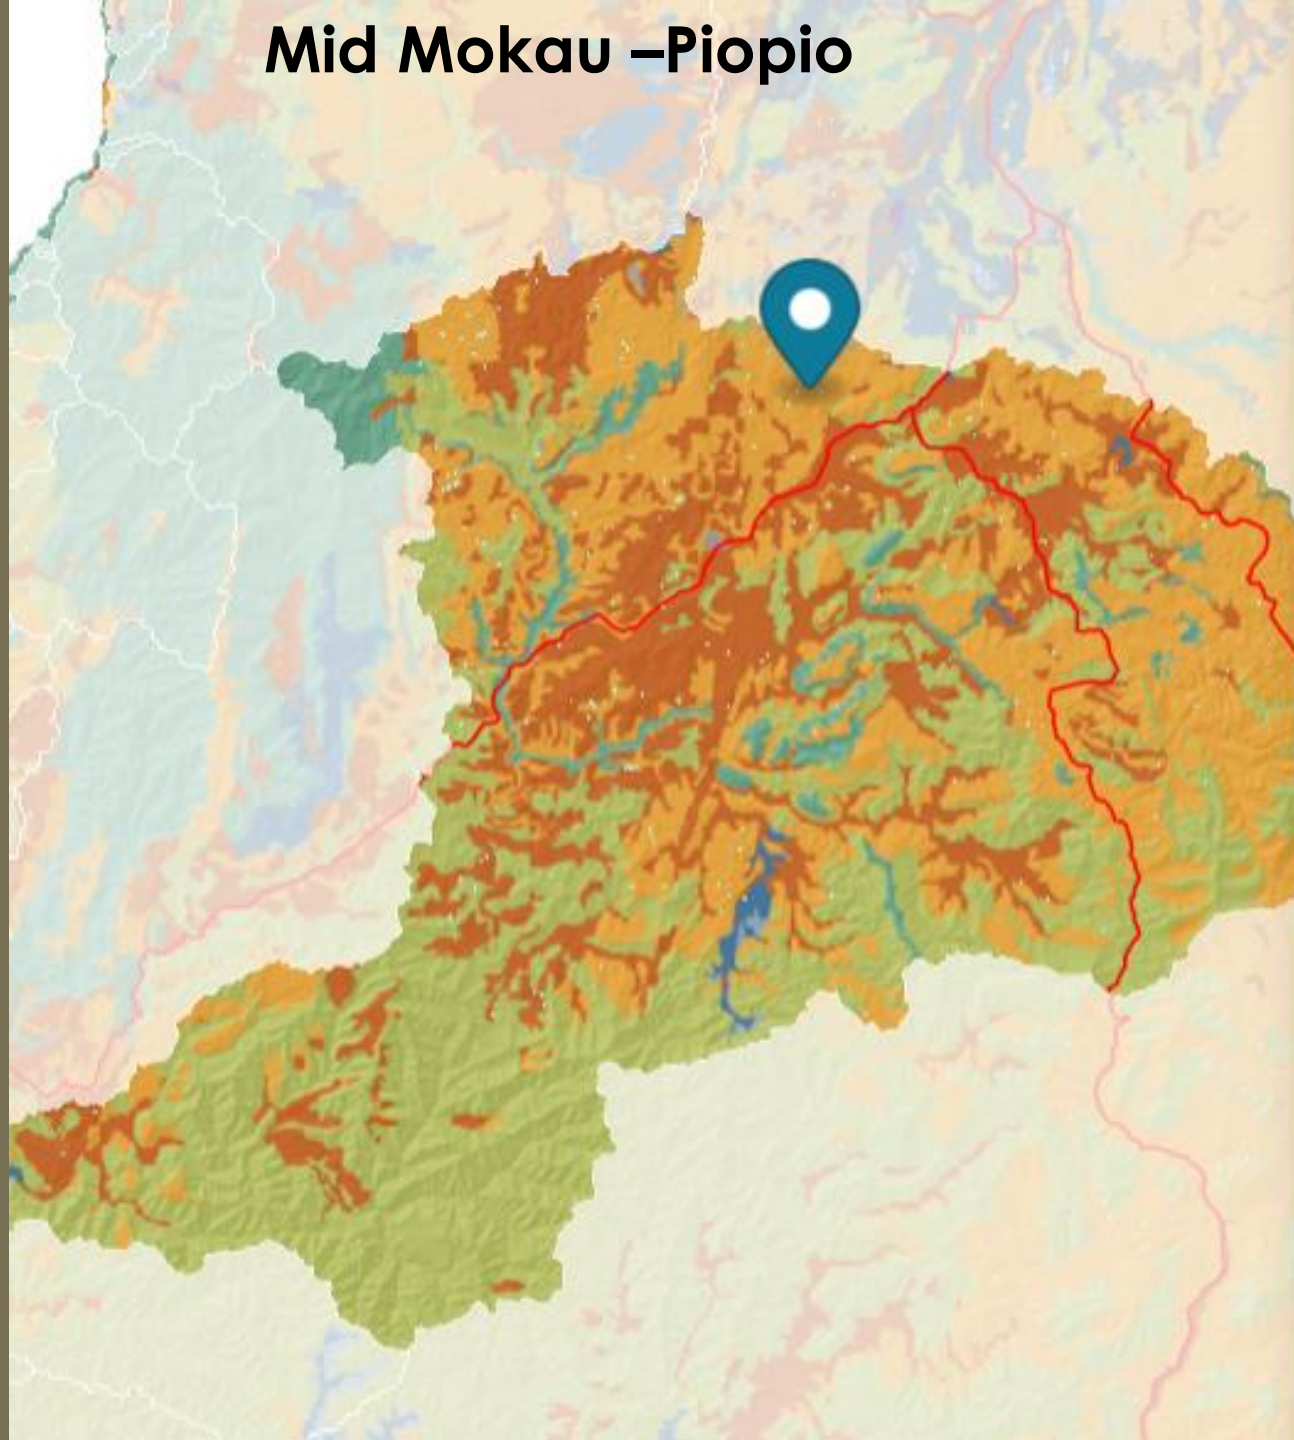
Mid Mokau –Piopio

Oxidising Soil & Aquifer

Hydrological Pathway	Deep drainage
Contaminant Risk	Nitrate nitrogen
Surface water catchment	Mokau River

- Predominantly occurs in lowland, low relief areas where there are moderately-well to well drained soils and oxygen-rich (oxidising) underlying aquifers.
- Runoff risk is elevated in areas of sloping or slowly permeable soils.

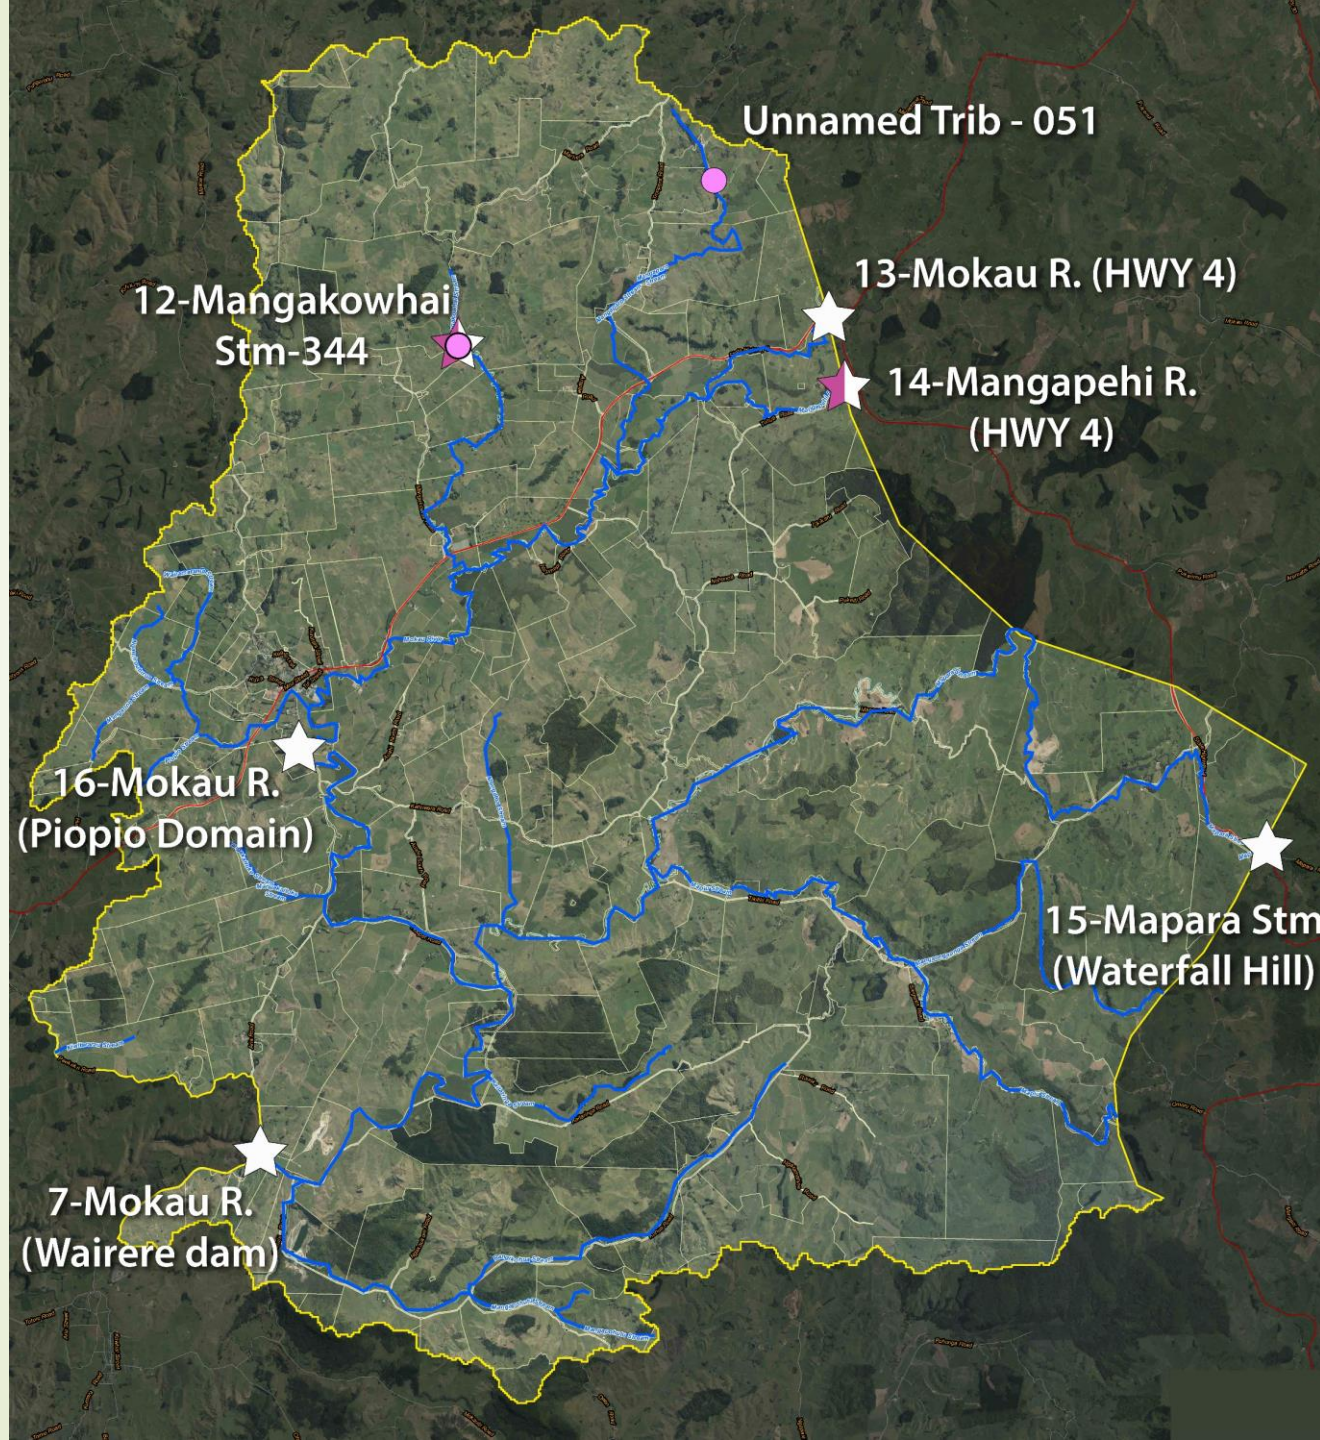
- Monitoring Sites**
-

Aquatic Life - WRC
 -

Water Quality - WRC
 -

River Flow - WRC
 -

Water Quality - KCRC
 -

eDNA - KCRC

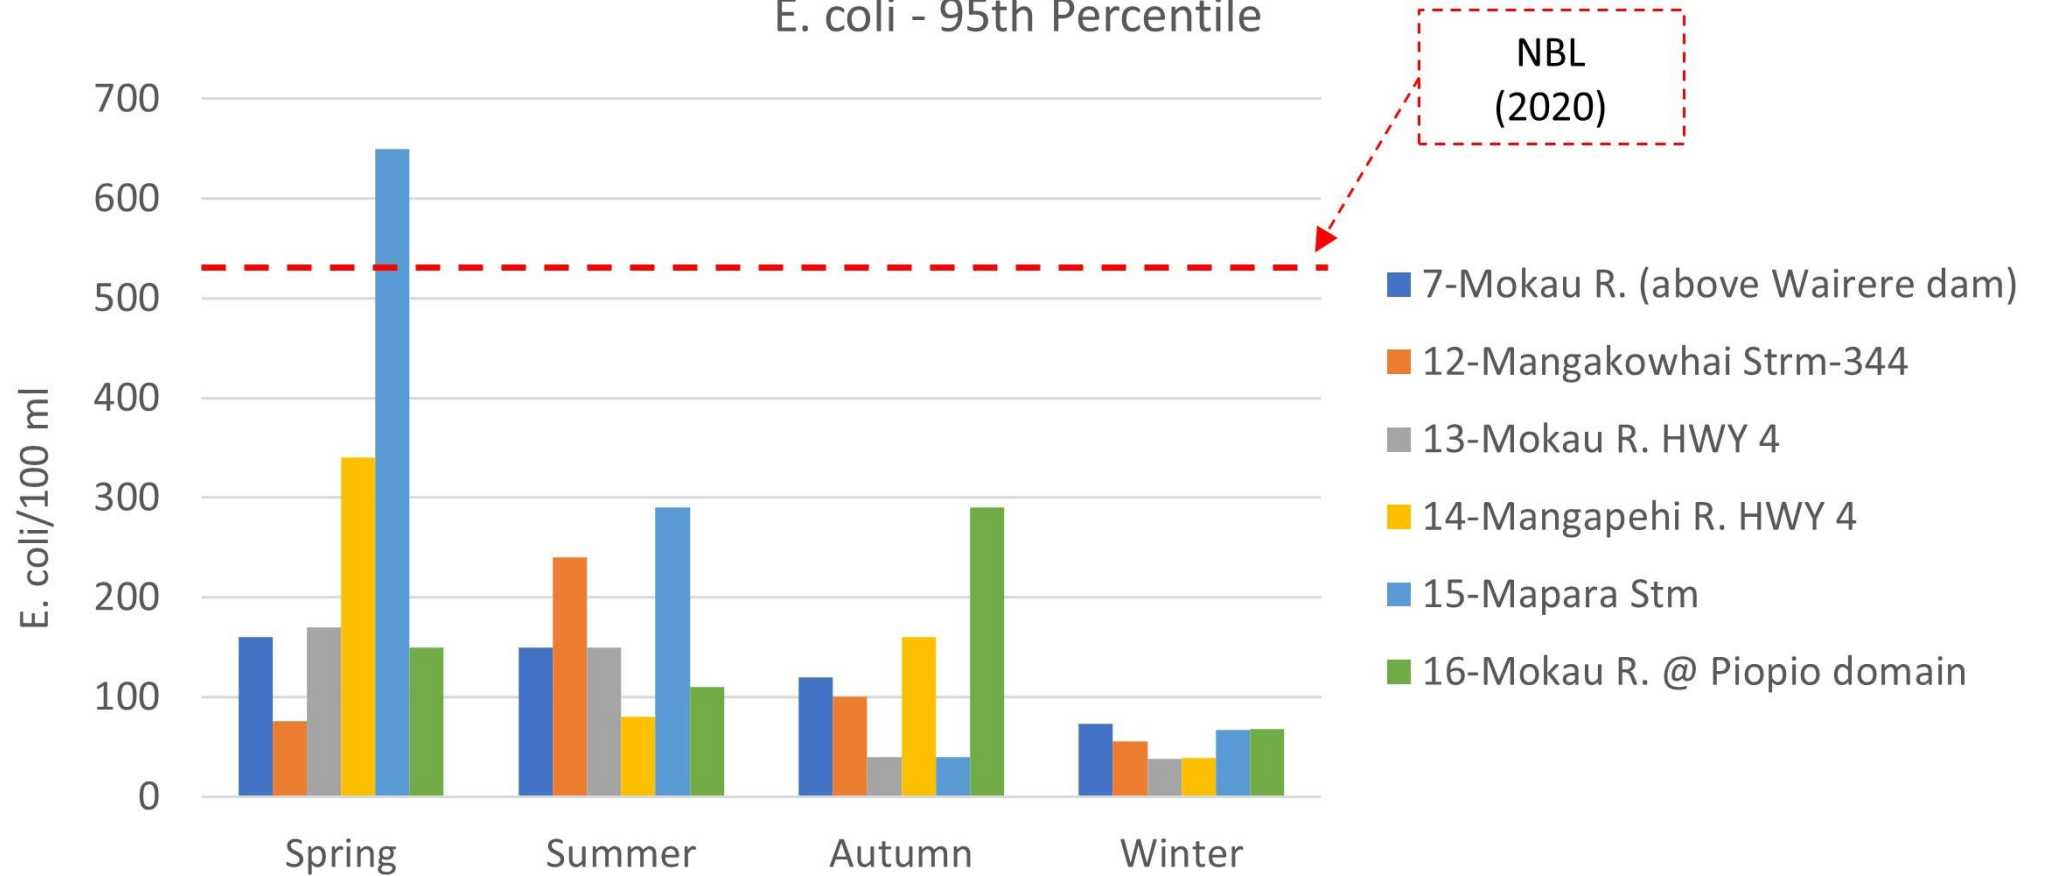
Mid Mokau-Pio Pio E. coli - 95th Percentile

E. Coli – Seasonal Results

- E. coli and water clarity are the attributes to watch
- DRP and Nitrate are elevated at 12-Mangakowhai Stm
- Highest WQ at 13-Mokau R. HWY4
- Lowest WQ at Mangakowhai Stm

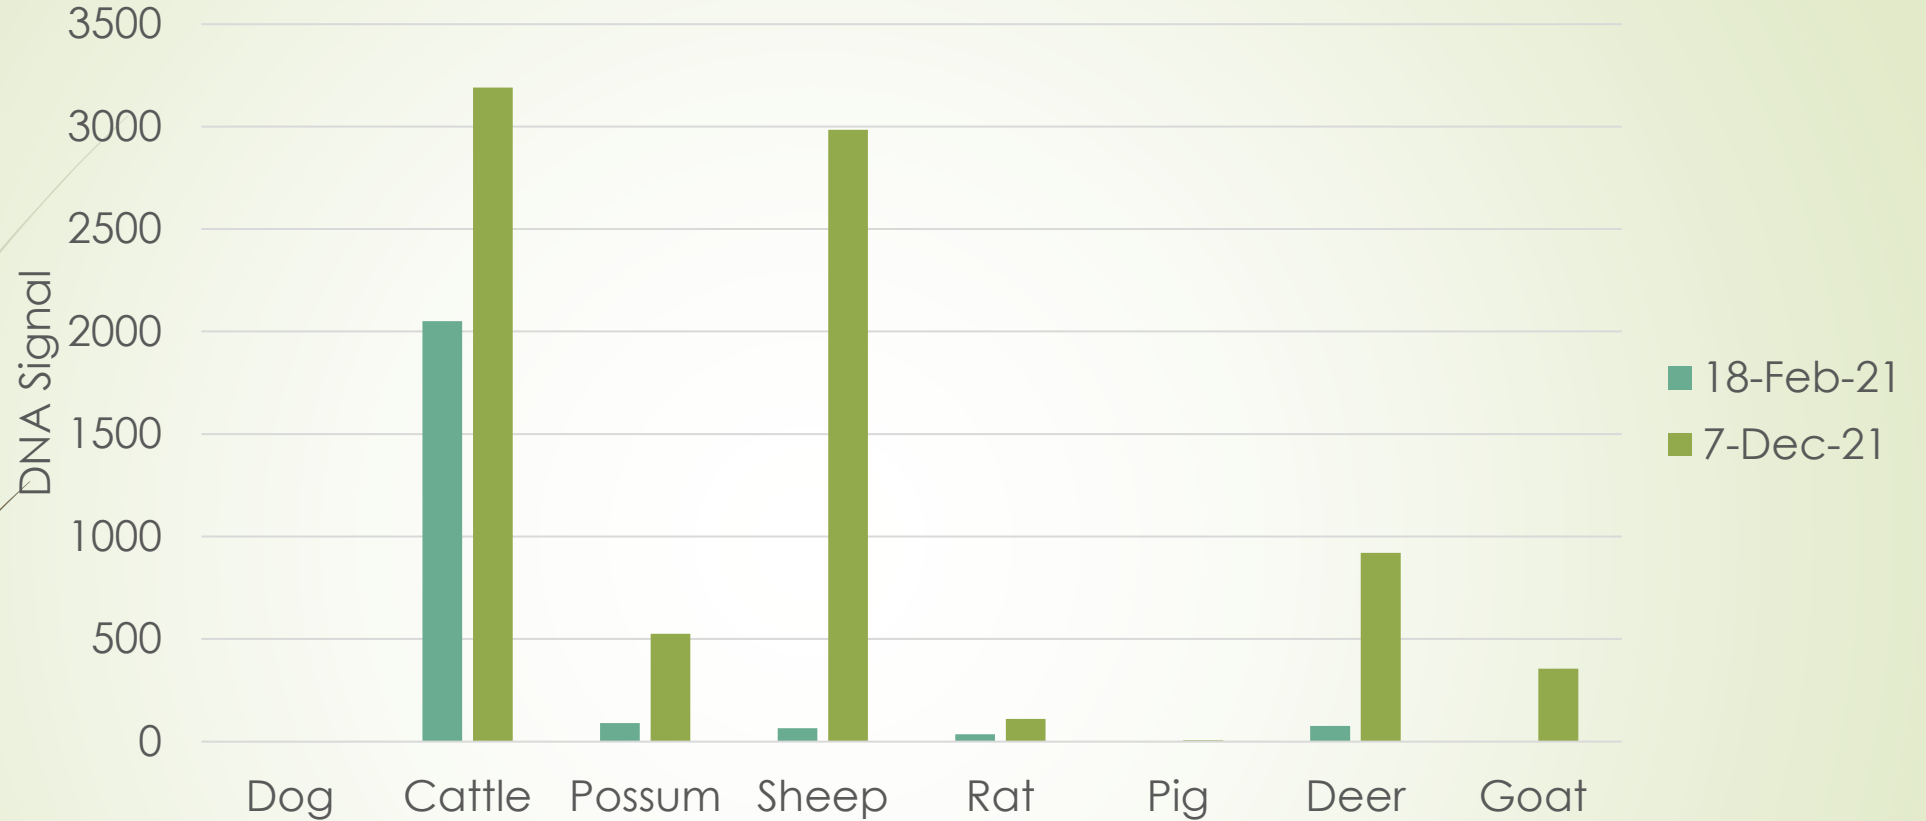
Mammals - 4. Mangakowhai Stream

Mammalian eDNA Signal Strength

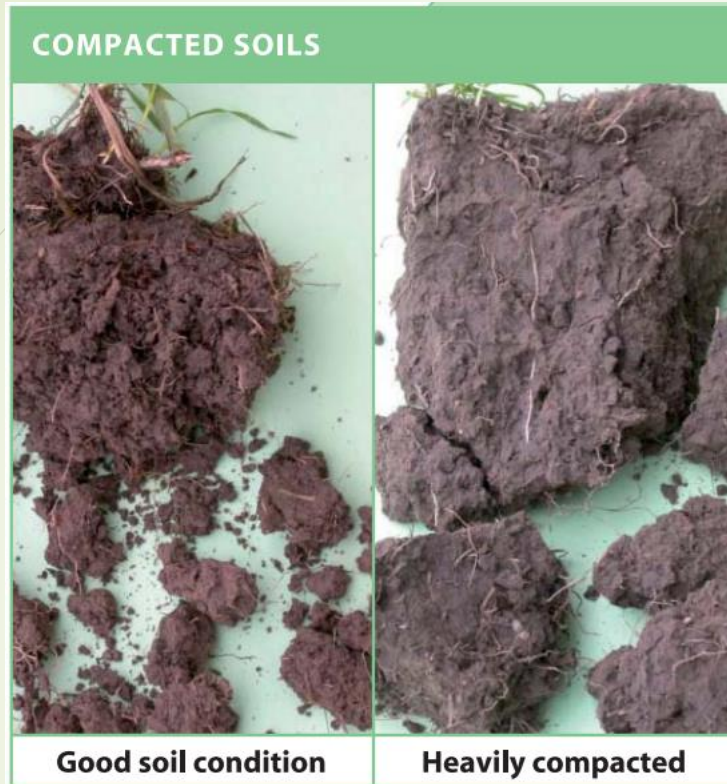
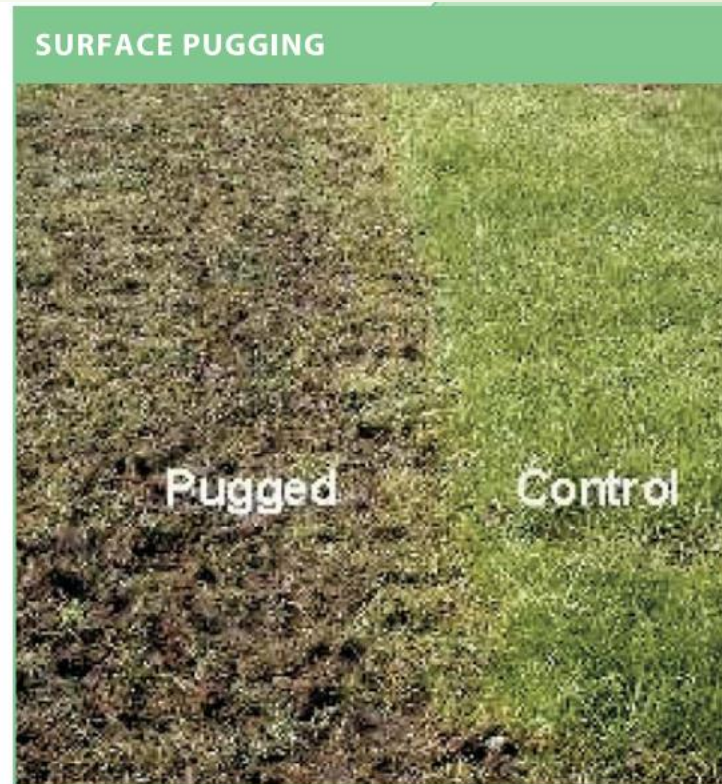
Soil Damage - Pugging

Overgrazing & soil damage

- Reduces spring pasture production by up to 80%
- Can take 3 or more years to recover.

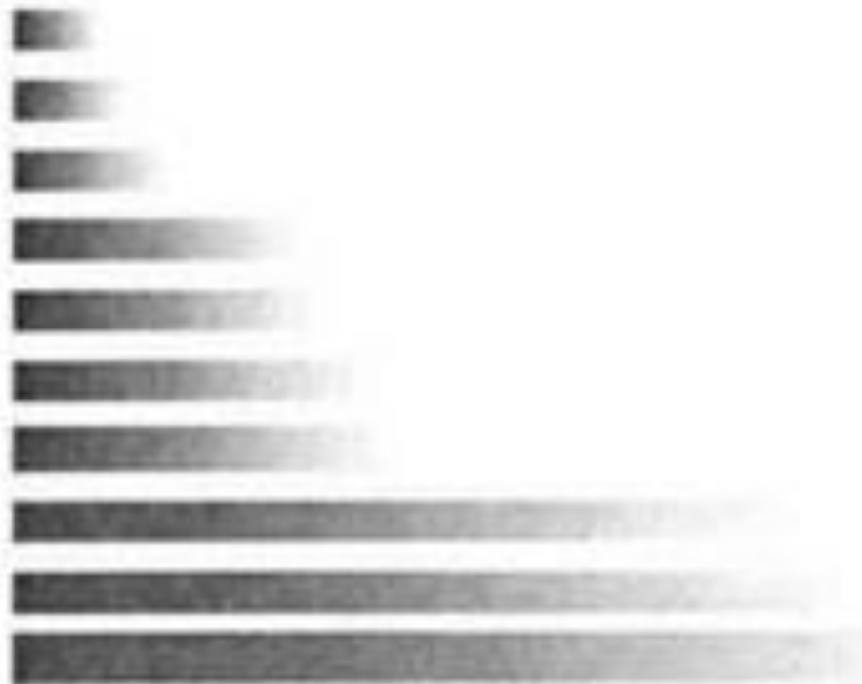
Diagram from conference paper by J Quinn (2012)

Riparian management - results from New Zealand

Riparian management schemes assessed, showing measures of water quality and stream health recorded as better (+), worse (-), or no change (=) in the buffer compared to the control reach for each variable.
